Fire Station 51 Assessment Report

CHELAN COUNTY FIRE DISTRICT NO. 5

MANSON, WASHINGTON

December 14, 2010

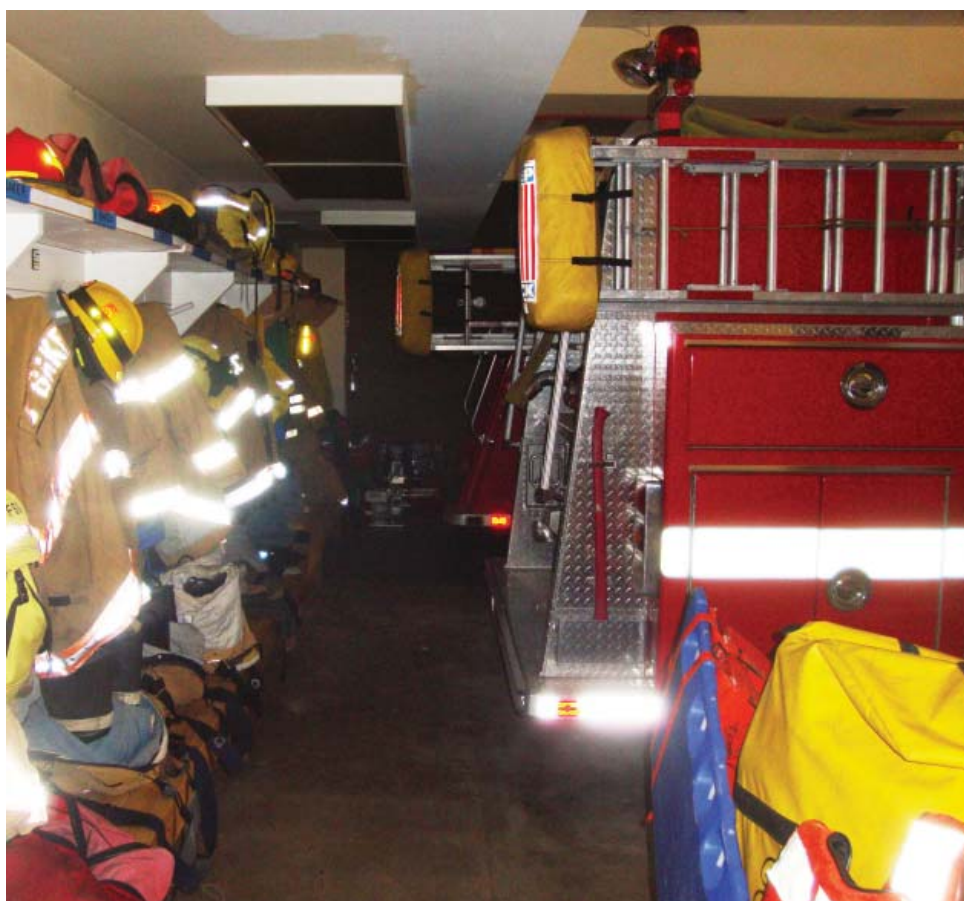
- **Bunker Gear:** The bunker gear is stored in the apparatus bay exposed to diesel and gas exhaust fumes from the apparatus, natural and artificial light, and minimal air circulation. The best management practice would be to store bunker gear in a dedicated room. A dedicated room serves to limit the amount of natural and artificial light, and provide good ventilation for drying. This serves to protect the fabric of the bunker gear from pre-mature deterioration.

Bunker Gear Storage At Rear Of South Apparatus Bay

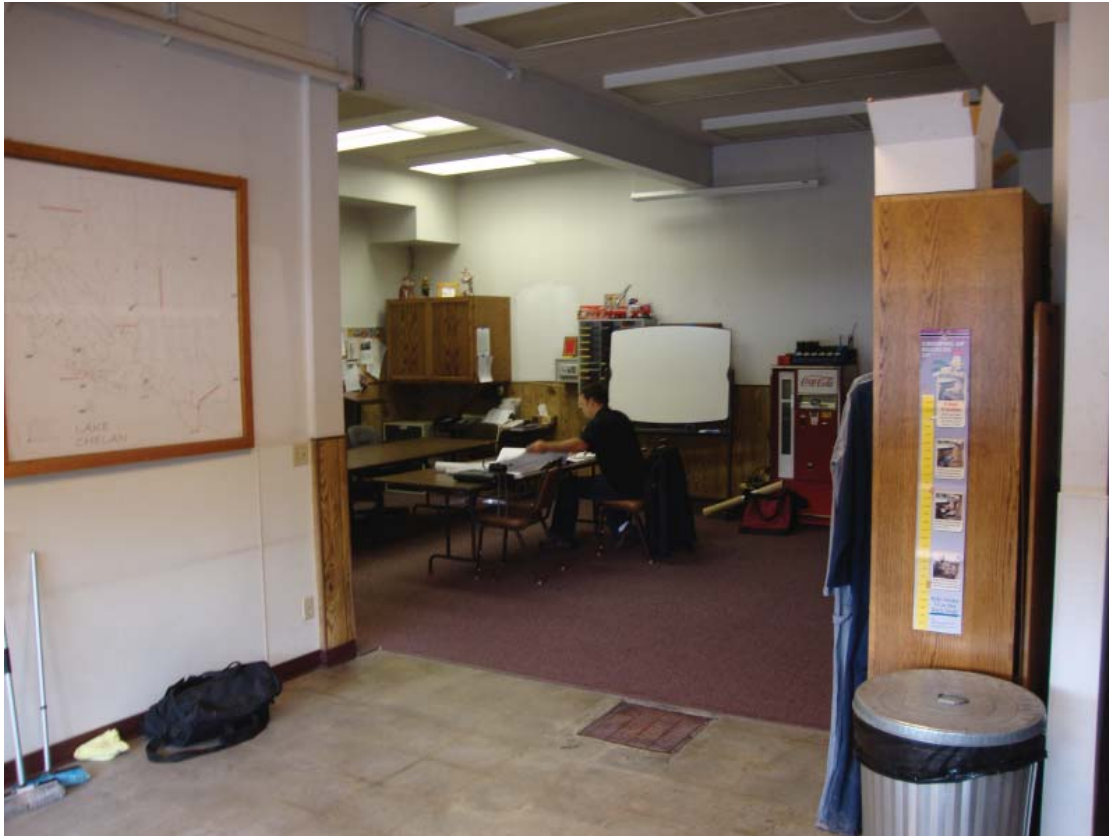
- Environmental & Life Safety: There is no floor to ceiling wall that separates the existing apparatus bays from the meeting area and rear portion of the building. As a result, odors and fumes created by the apparatus parked within are noticeable throughout the fire station (ground floor only). The station is equipped with a diesel exhaust fan that is manually operated when apparatus deploy and return to the station.

Meeting Area Open
To South Apparatus
Bay

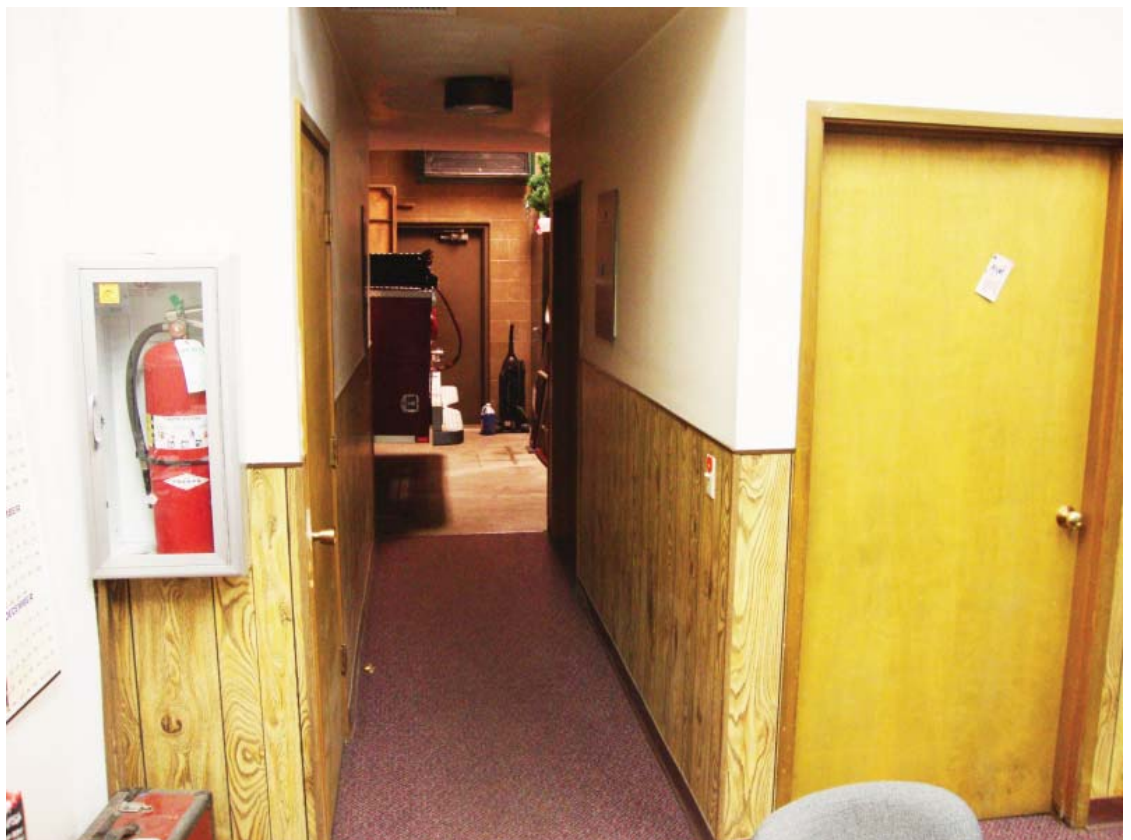
Meeting Area &
Hallway Open To
North Apparatus
Bay
