# Fire Station-52 Assessment Report

## *CHELAN COUNTY FIRE DISTRICT 5*

JULY 30, 2012

**Assessment By: Chief Arnold Baker**

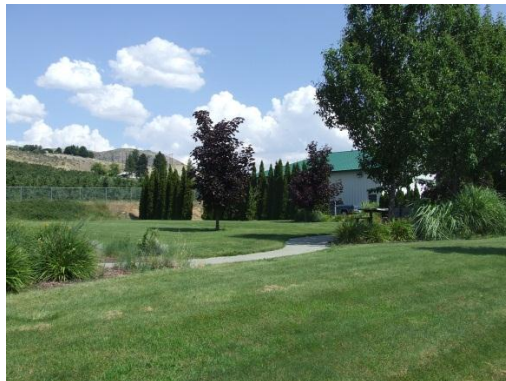
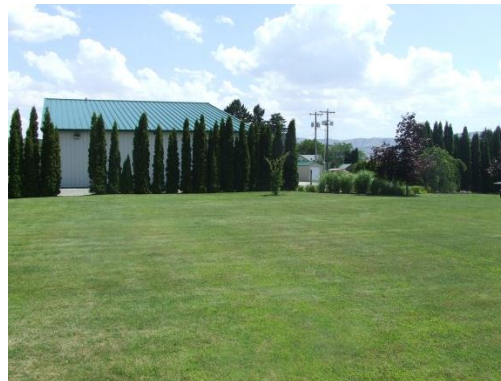
Station-52 is a 4996 square foot rigid metal building constructed in 1995. The facility consists of (4) 18' x 49' bays, entrance meeting room with radio area and kitchenette, men's and women's restrooms with showers, office/storage room, mechanical room and 990' mezzanine meeting area. In December 2009 the mezzanine was remodeled to add (2) sleep rooms. This remodel does not meet Chelan County occupancy requirements. Temporary occupancy was allowed by placing the rooms to the front of the building where secondary egress can be made through the windows installed in the original construction.

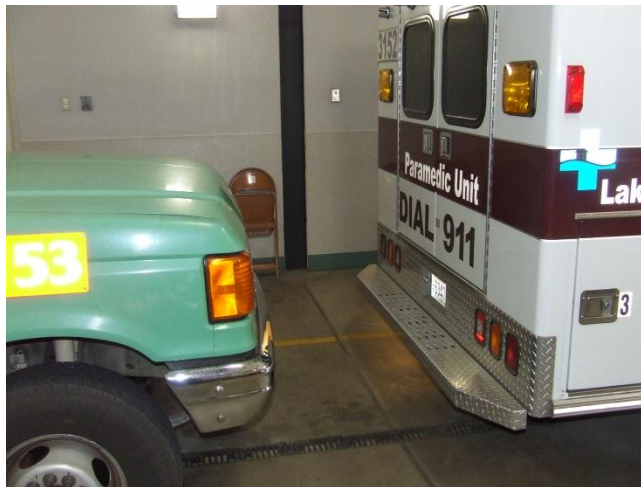
- As described in section 2), the bay size is good for most apparatus. In Bay 2, there are a 1-ton Brush apparatus and an Ambulance. The bay length is not sufficient for two shorter vehicles. Whereas the Washington Administrative Code states that three feet of clear area be provided for each apparatus. (Six feet between apparatus) this bay has approximately 2 feet between apparatus and each end. This also has some risk for parking in the bay without spotters to visually check distances for the driver.

- All bays meet the three foot minimum clearance around apparatus, except bay-2 with two apparatus sharing the bay where distances are approximately two feet between apparatus and two feet in front and behind the apparatus.

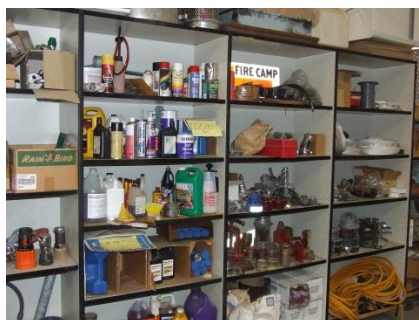
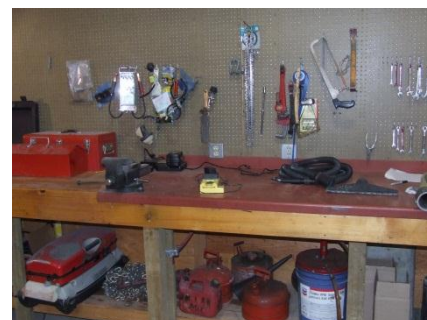
- This facility was designed to be simple with a rural volunteer fire department needs. Storage was not planned as part of the goal when the facility was conceptualized. Storage was an afterthought and utilized space and materials available to create some.
- Storage shelving was made available at no cost right after construction to provide storage for hose fittings and supplies. A workbench was added to the back wall behind Bays 1 & 2 with shelving and drawers built in.

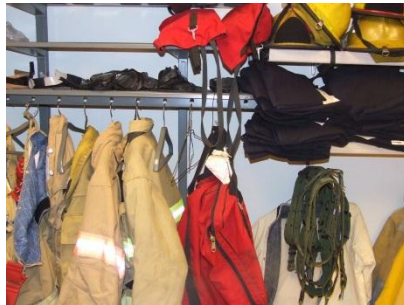
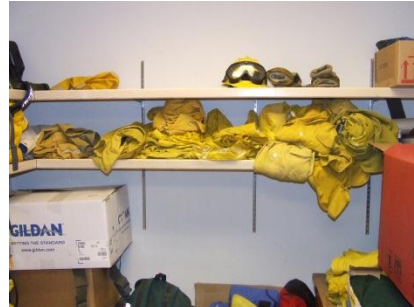
- In the plans for the building, an officer's office was created. That has since changed to a Personal Protective Equipment (PPE) storage room that is too small. This room can be secured if valuables need protection.

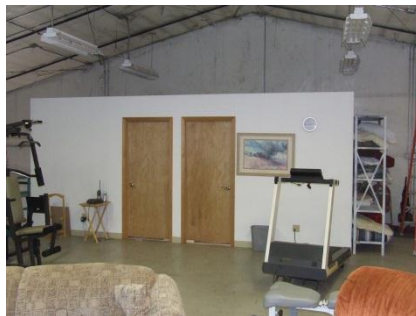
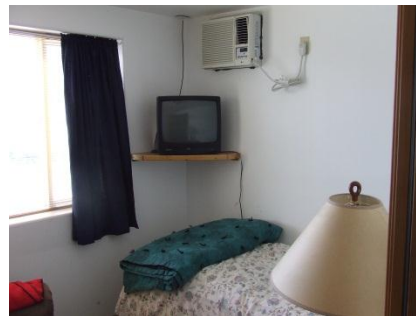
- The December 2009 remodel adding two sleeping rooms, made an area on the mezzanine where personal effects of the duty staff could be stored. Metal shelving was made available by the Hospital to hold these personal effects. This storage is not secure from others that also have access to the building.

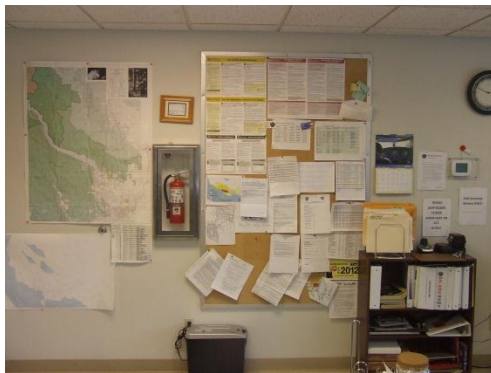
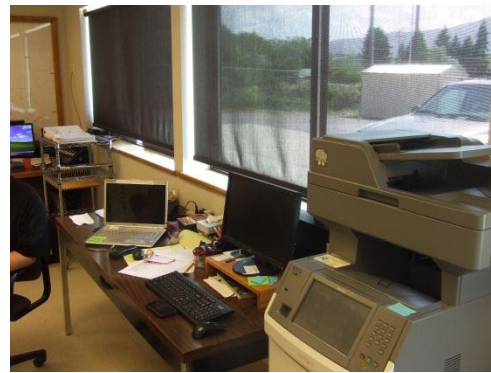
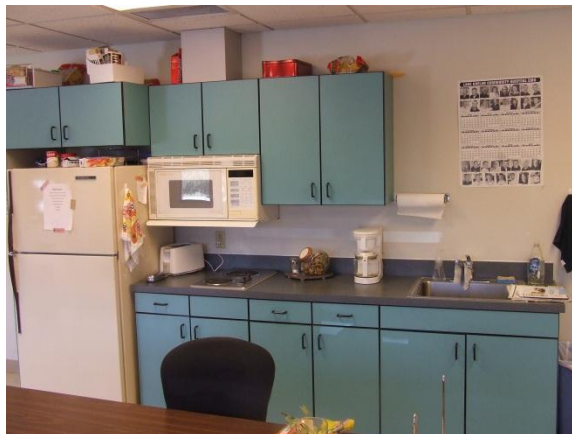
- The main entrance to the station leads directly into a day room for the duty personnel. This room holds the station base radio, kitchenette, duty administrative work area for both Fire and EMS staff, whiteboard for drill presentations and meal table.
- We welcome the public to the station. We run the risk of having medical patient reports unsecured in the first room the public enters. A lobby is necessary to provide a separation from administrative areas and where the public would enter to have a blood pressure taken.
- The day room/ kitchen/ dining area should be separated from public areas to allow duty staff, that many of which work 48-hour shifts, to have a personal area.

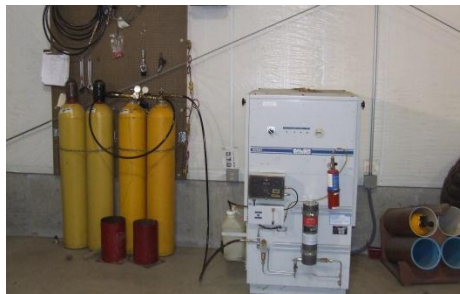
- This facility houses a Bauer breathing air compressor purchased in the early 1990's. The compressor unit is maintained meeting all the minimum scheduled service requirements. Air samples are take each quarter and mailed to a testing laboratory for analysis. The unit is rated 8.4-cubic feet per minute at 4500-psi. Large air cylinder storage is connected to the compressor to fill self-contained breathing apparatus cylinders rapidly in the event of a large fire.
- The air intake is not ported outside the building, in which the compressor can draw in room air with contaminates from apparatus that may have run before the compressor turned on.

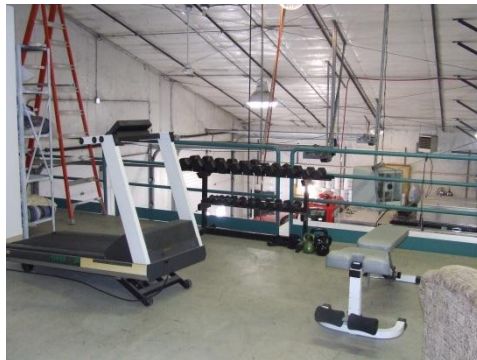
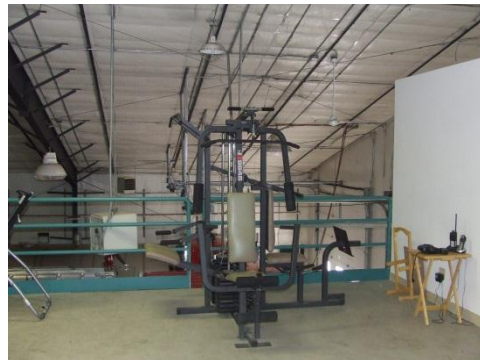
- On the mezzanine and outside the sleeping rooms, are several pieces of fitness equipment. While it is very convenient for those on duty, it is very concerning for off duty personnel intruding other than daytime hours. A fire station design should address fitness areas away from sleeping areas to benefit the whole department.
